Croat Med J. 2018;59:253-7

Femoral head wear and metallosis caused by damaged titanium porous coating after primary metal-on-polyethylene total hip arthroplasty: a case report

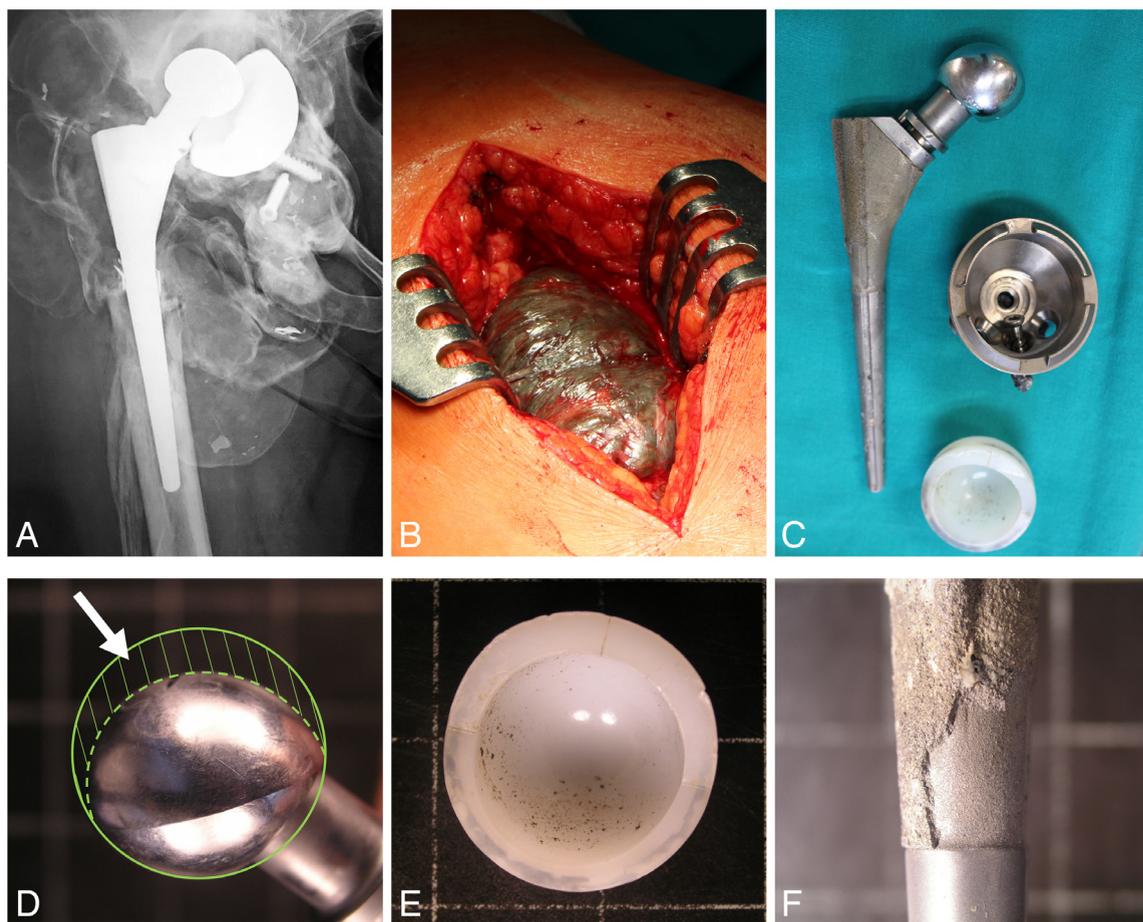
FIGURE 1. (A) Preoperative anteroposterior right hip x-ray showing acetabular cup dislocation, eccentric femoral head wear, “cloudy bubbles,” and pseudotumor formation; (B) intraoperative image after a direct lateral approach to the right hip showing extensive metallosis; (C) intraoperative image of the extracted endoprosthetic components; (D) eccentric wear of the femoral head (posterior view, arrowhead pointing approximately at the worn part of the femoral head); (E) metal debris particles embedded in the acetabular polyethylene – most of the particles are embedded in the part of the liner that was not in contact with the worn femoral head; (F) damaged titanium porous coating on the extracted femoral stem.

The initial x-ray examination in 2018 showed acetabular cup dislocation, eccentric femoral head wear, “cloudy bubbles” characteristic of metallosis, and pseudotumor formation (Figure 1A). It also showed damage to the titanium porous coating of the femoral stem. A review of the medical records from 2016 revealed femoral head wear *in situ* and damage to the porous stem coating. A revision surgery was indicated, and the patient agreed to the procedure.

During surgery, performed using direct lateral approach, extensive metallosis was observed (Figure 1B, [Supplemen-](#)

[tary Video 1](#)). After thorough debridement and irrigation, all implant components were removed (Figure 1C). The femoral head was gravely worn and elliptically shaped (Figure 1D). The polyethylene liner on the acetabular side had no visible holes or cracks, suggesting there was no direct contact between the femoral head and metal acetabular shell. After endoprosthesis extraction, notable polyethylene liner wear was visible, with metal debris covering the inner surface (Figure 1E). Due to a large acetabular bone defect, it was decided not to proceed with a new acetabular cup implantation. In the postoperative period, a coxofemoral orthosis was applied, and crutches were used for touchdown weight-bearing only. Intraoperatively collected microbiology culture swabs were negative for aerobic and anaerobic microorganisms.

Macro- and micro-structure of all extracted components were analyzed in detail at the Faculty of Mechanical Engineering and Naval Architecture of the University of Zagreb. The analysis revealed macroscopic damage to the titanium porous coating of the femoral stem (Figure 1F) and a decreased volume of the femoral head. Metal debris on the acetabular liner was distributed heterogeneously; fewer debris particles were present on the part of the liner adjoining the worn femoral head than on the remaining part of the liner. The surface damage features of the polyethylene were characterized by scanning electron microscopy (SEM) (TESCAN VEGA TS5136LS, TESCAN ORSAY HOLDING a.s., Brno-Kohoutovice, Czech Republic). SEM revealed damage, scratches, indentations, and embedded metal debris particles on the whole acetabular liner surface (Figure 2A). Chemical composition and origin of these particles were determined using energy-dispersive spectroscopy (EDS, OXFORD Instruments, Abingdon, UK), which showed that metal debris consisted of both titanium and stainless-steel particles (Figure 2B).

Our study showed that detached titanium porous coating of the femoral stem can cause the stainless-steel femoral head wear in primary metal-on-polyethylene THA. As soon as such detachment becomes evident on routine follow-up radiographs, revision surgery should be considered to prevent devastating complications described in this report.

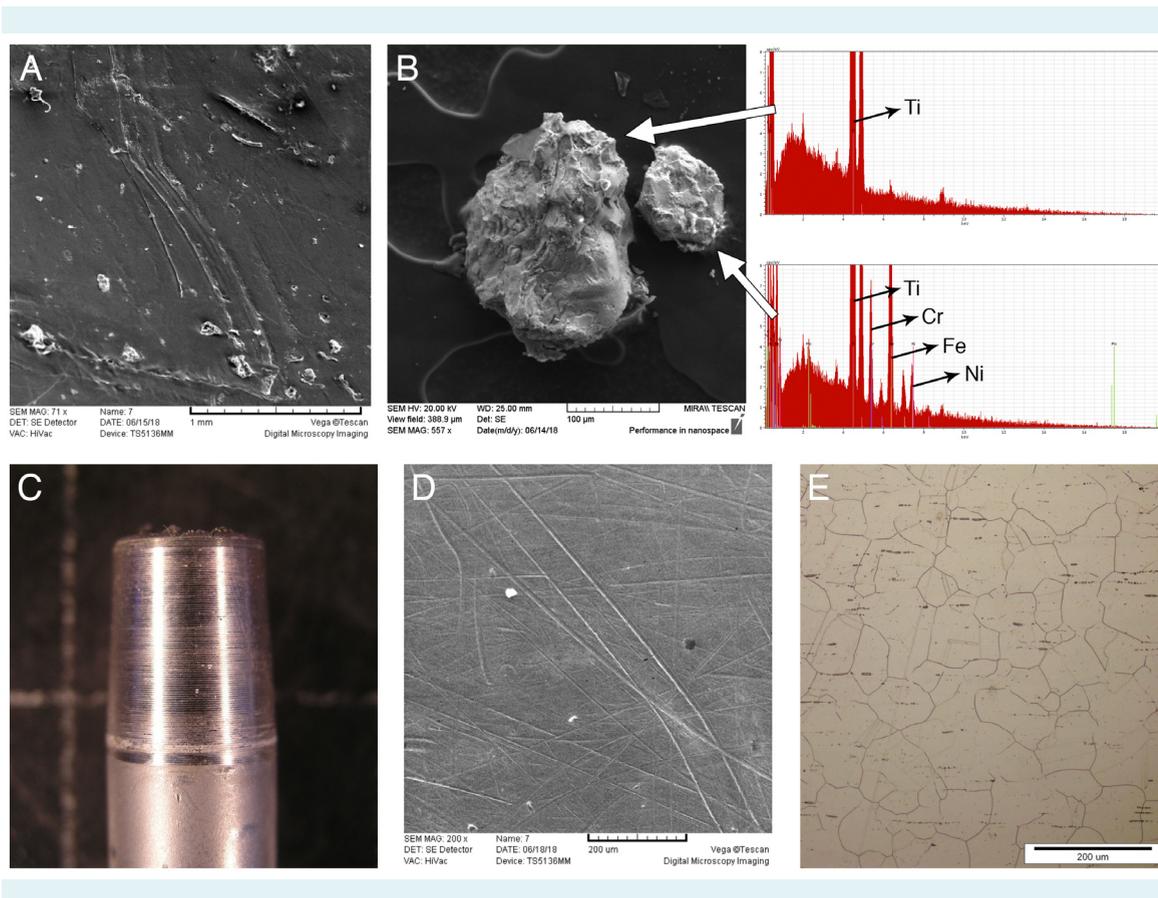
FIGURE 2. (A) Scanning electron microscopy image of the acetabular liner surface that was in contact with the worn femoral head, revealing damage, scratches, indentations, and embedded metal debris particles; (B) energy-dispersive spectroscopy image showing that the metal debris embedded in the acetabular liner contains both titanium and austenitic stainless-steel particles; (C) the femoral neck at the neck-head junction showing no signs of trunnionosis; (D) scanning electron microscopy image of the femoral head surface revealing scratches and damage typical for abrasive mechanical wear; (E) microstructure of the femoral head material typical for that kind of material: homogeneous austenitic without any significant defects or other irregularities. Abbreviations: Ti – titanium; Cr – chromium; Fe – iron; Ni – nickel.

Femoral head component (AISI 316L stainless-steel) was removed from the femoral neck, and no signs of trunionosis were observed at the head/neck junction (Figure 2C). To determine the wear mechanisms, the wear tracks on the femoral head surface were analyzed by SEM, and only traces of abrasive wear were found (Figure 2D). The microstructure of the femoral head material was typical for this type of material: homogeneous austenitic without any significant defects or other irregularities (Figure 2E), with microhardness of 145 HV 0.2 (mean value of 5 measurements).

The main concern of this study was to determine the origin of the metal particles on the polyethylene surface and the type of femoral head wear. The SEM and EDS analysis showed the presence of titanium and austenitic stainless-steel particles (Figure 2B), suggesting that the origin of the titanium particles was the detached titanium porous coating of the femoral stem (Figure 1F). The SEM analysis of the femoral head confirmed that the wear was of the abrasive type and was probably caused by the titanium particles on the polyethylene surface because the hardness of stainless steel femoral head was lower than the titanium hardness described in the literature (145 compared to 200-362 HV 0.2) (6,7).
